How to Select the Correct Diaset Core Bit

Selection Guide & Troubleshooting Tips

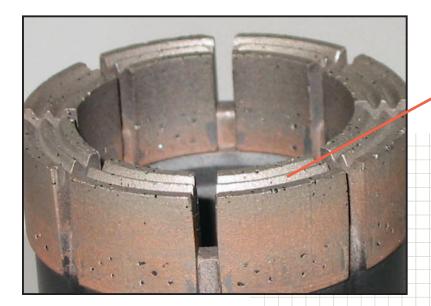
New Bit & Normal Wear Pattern

New Bit Observation

v-ring pattern allows bit to start drilling quickly, stabilizes bit to bottom of hole.

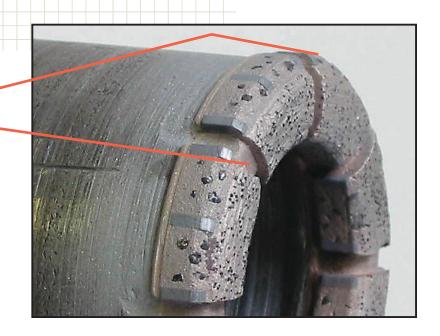
Normal Wear

- O.D. and I.D. gauge intact
- flat to slight rounded profile
- "teardrop" matrix wear pattern behind diamond

Comments

- correct drilling procedure
- correct matrix selection

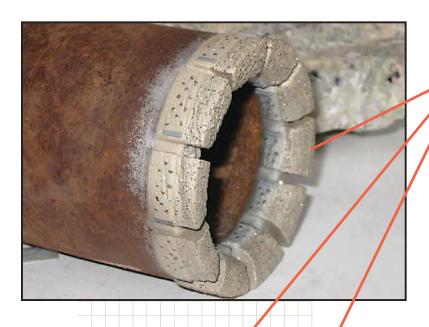
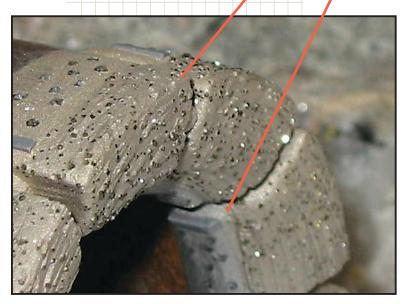
I.D. Gauge Problems

Observations:

- rounded wear to I.D.
- excessive diamond exposure
- complete loss of I.D. gauge

Probable causes:

- Hard, broken or fractured formation
- excessive penetration rate for the RPM used
- insufficient fluid flow
- mis-latched innertube
- high bit load
- improper innertube adjustment

Possible solutions:

- retrieve innertube immediately upon core block
- clean hole properly before each core run
- use a harder (lower number) matrix
- increase pump output.
- check rod string for leaks, split rods
- adjust innertube to allow more fluid flow
- increase RPM

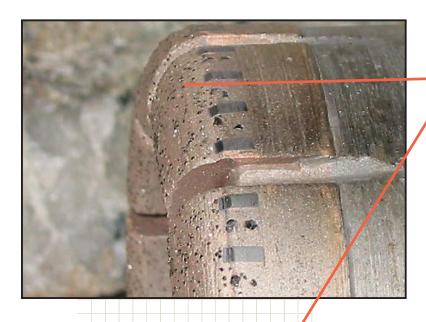
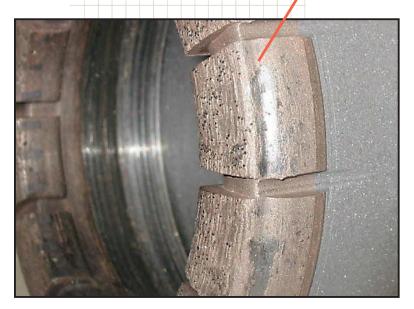
O.D. Gauge Problems

Observations:

- rounded wear to O.D.
- complete loss of O.D. gauge

Probable causes:

- vibration
- excessive RPM
- bit reaming down an undersize hole
- bit following a worn bit
- insufficient fluid flow (attempting to make bit cut faster)

Possible solutions:

- alter RPM to reduce vibration. May have to change matrix to suit new RPM
- stabilize drill string
- adjust bit weight to reduce vibration
- check reaming shell, replace if undersized
- start drilling with new bit well before bottom of hole to ensure hole size matches new bit.
- increase fluid flow
- softer (higher number) matrix

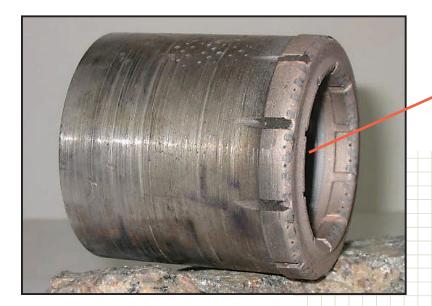
Burnt & Polished Bits

Burnt Bit Observations:

- melted crown.
- diamonds and waterways fused

Probable causes:

- insufficient fluid flow
- split drill rod(s)

Possible solutions:

- check pump
- check innertube adjustment
- check rods for leaks or cracks
- increase fluid flow

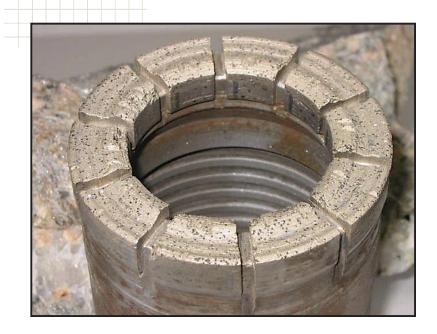
Polished Bit Observations:

- no or poor diamond exposure
- smooth surface

Probable causes:

- wrong matrix selection, diamond concentration too high
- drill too small to push this bit

Possible solutions:

- use a softer (higher number) matrix
- try decreasing fluid flow rate slightly
- sandblast face of bit to expose diamonds
- maintain torque, keep the bit cutting
